US Army Corps of Engineers Construction Engineering Research Laboratories

# Investigation of Fiberglass-Reinforced Plastic (FRP) Condensate Return Carrier Piping

by Orange S. Marshall, Jr. and Charles P. Marsh

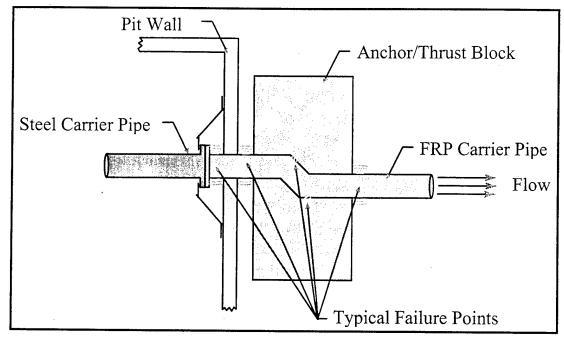
When the FRP pipe breaks, it is typically either in or within a few inches of the manholes or the concrete anchors (Figure 4). This may have several causes, including: (1) settling of the manholes and anchors over time, (2) settling of the anchor and not the manhole, or vice versa, (3) ground heave from freeze-thaw in cold climates, (4) thermal expansion and contraction of the pipe, or (5) a combination of two or more of any of these. When the pipe breaks, a significant

Figure 4. Typical failure points around manholes.

length of adjacent pipe is also damaged, requiring additional excavation and testing to find sound pipe to attach a repair section of pipe to.

A typical repair takes two or three men, a backhoe operator, a laborer, and a mechanic 8 to 10 hours to complete. This type of repair at or near a manhole consists of the following steps:

- 1. Turning the system off (and waiting for it to cool down)
- 2. Unbolting the flange in the manhole
- 3. Cutting out the concrete thrust block
- 4. Excavating the FRP pipe back to a point where it is round, and cutting it off there
- 5. Reaming the end and adding a flange to the FRP pipe
- 6. Running steel pipe for cut out portion of FRP pipe
- 7. Flanging both ends of the steel replacement
- 8. Bolting up the flanges
- 9. Turning the system on and checking it for leaks
- 10. Replacing the dirt fill (and doing any landscaping).
